PAPER GOODS POND DAM

CT 00253

PHASE 1 INSPECTION REPORT
NATIONAL DAM INSPECTION PROGRAM

MARCH, 1981

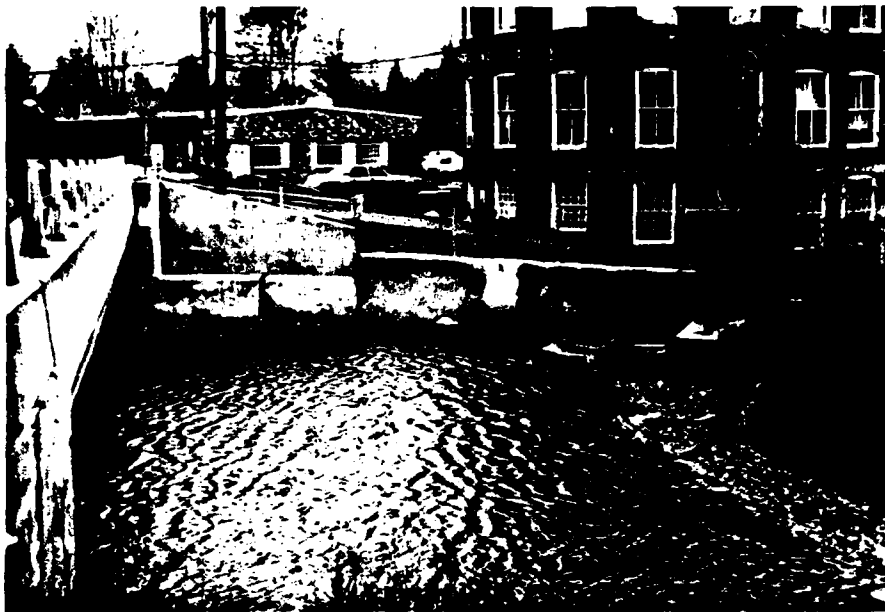
C-3 NORTHEAST END OF SPILLWAY SHOWING
OUTLET WORK CONTROLS
